Challenges in risk assessment Insidious erosion of safety margins over time

Insidious erosion of safety margins over time

Alaska Airlines flight 261

Loss of Control and Impact with Pacific
Ocean Alaska Airlines Flight 261
McDonnell Douglas MD-83, N963AS
About 2.7 Miles North of
Anacapa Island, California
January 31, 2000

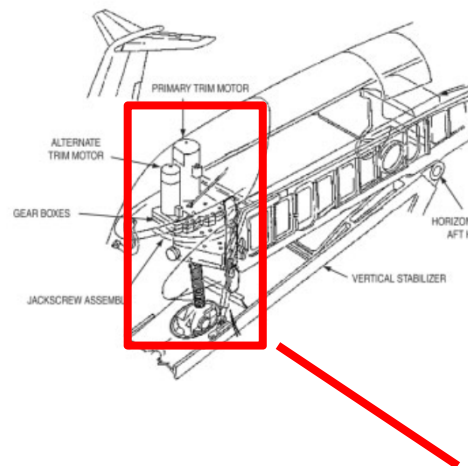
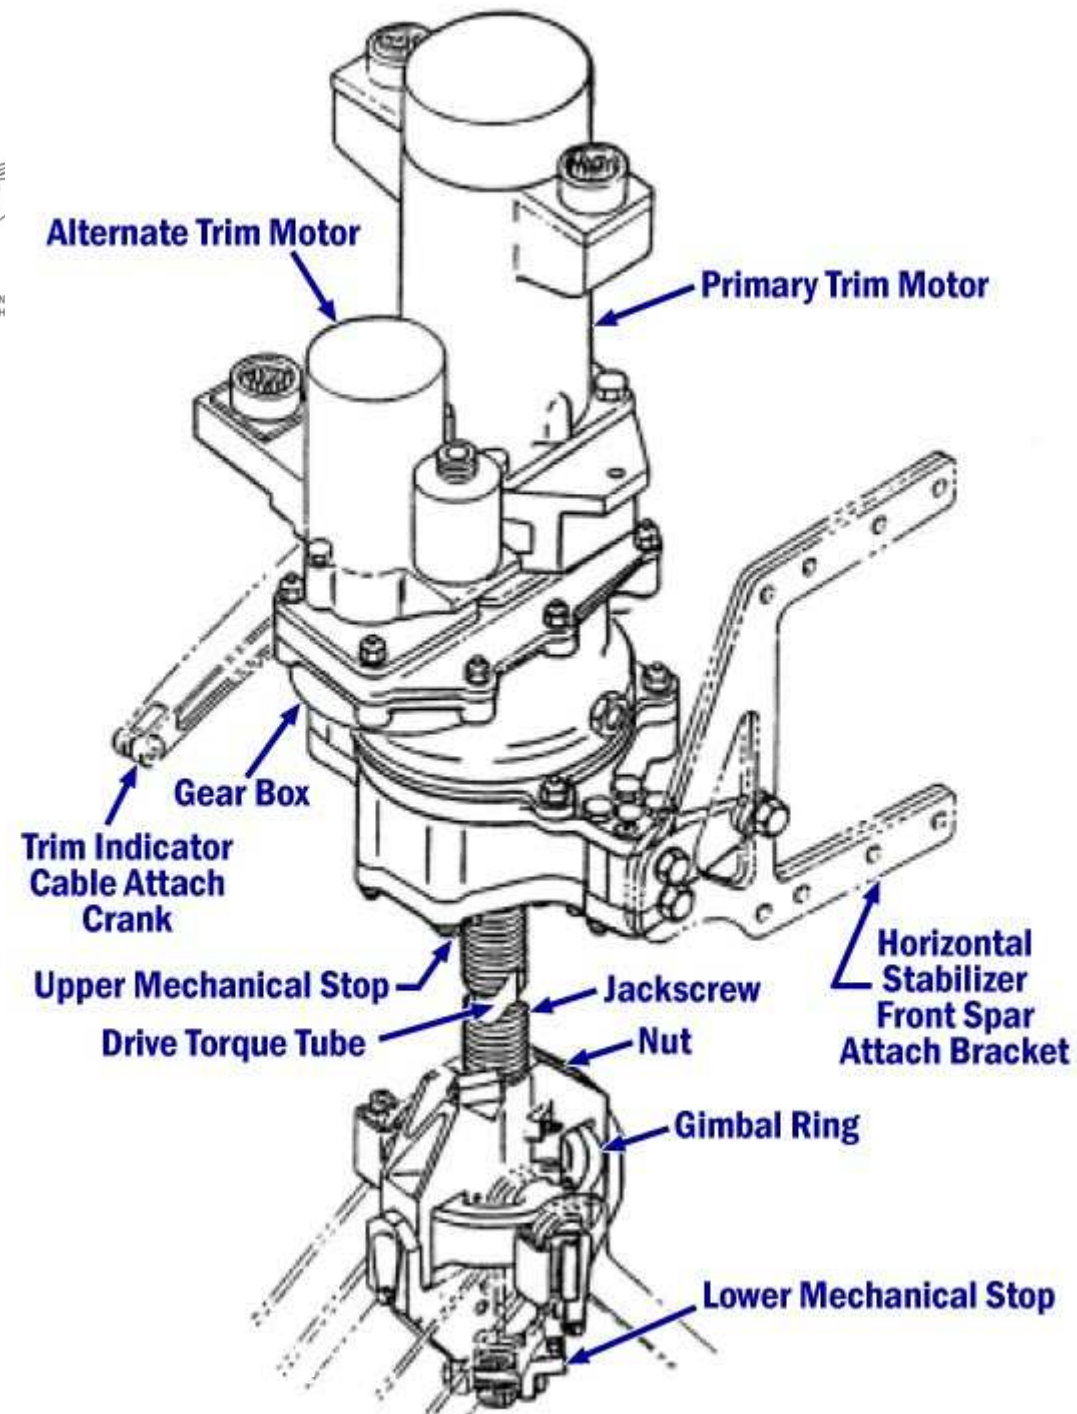
Acme nut severely worn

Approximately 90 percent of the thread thickness had worn away before the remainder of the threads sheared off.

Cause of excessive wear: Lubrication failure

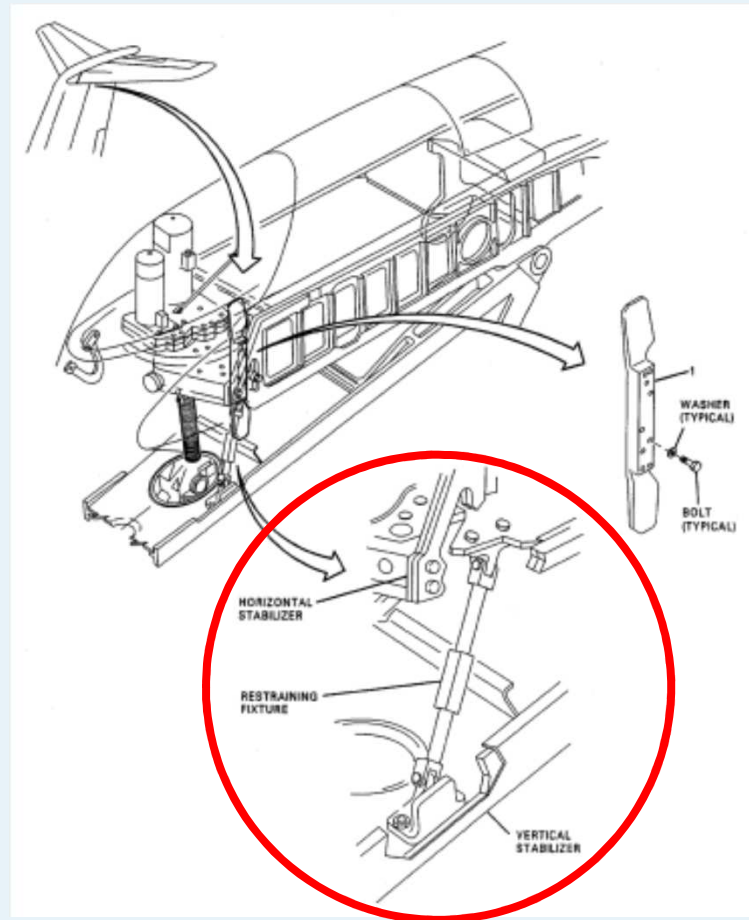
Measuring nut thread wear - using a "restraining fixture"

To allow operators to monitor acme nut wear without removing the jackscrew assembly from the airplane, Douglas developed the on-wing end play check procedure. The procedure calls for pulling down on the horizontal stabilizer by applying a specified amount of torque to a tool known as a restraining fixture to change the load on the acme screw from tension to compression

Fixture manufactured in-house
